26 August 2020

**Subject: Gas Monitoring and Control System Restoration Completion Letter –
Response to Additional Comments from DTSC
Genentech Building 48
645 East Grand Avenue
South San Francisco, California 94080
Langan Project No. 731677307**

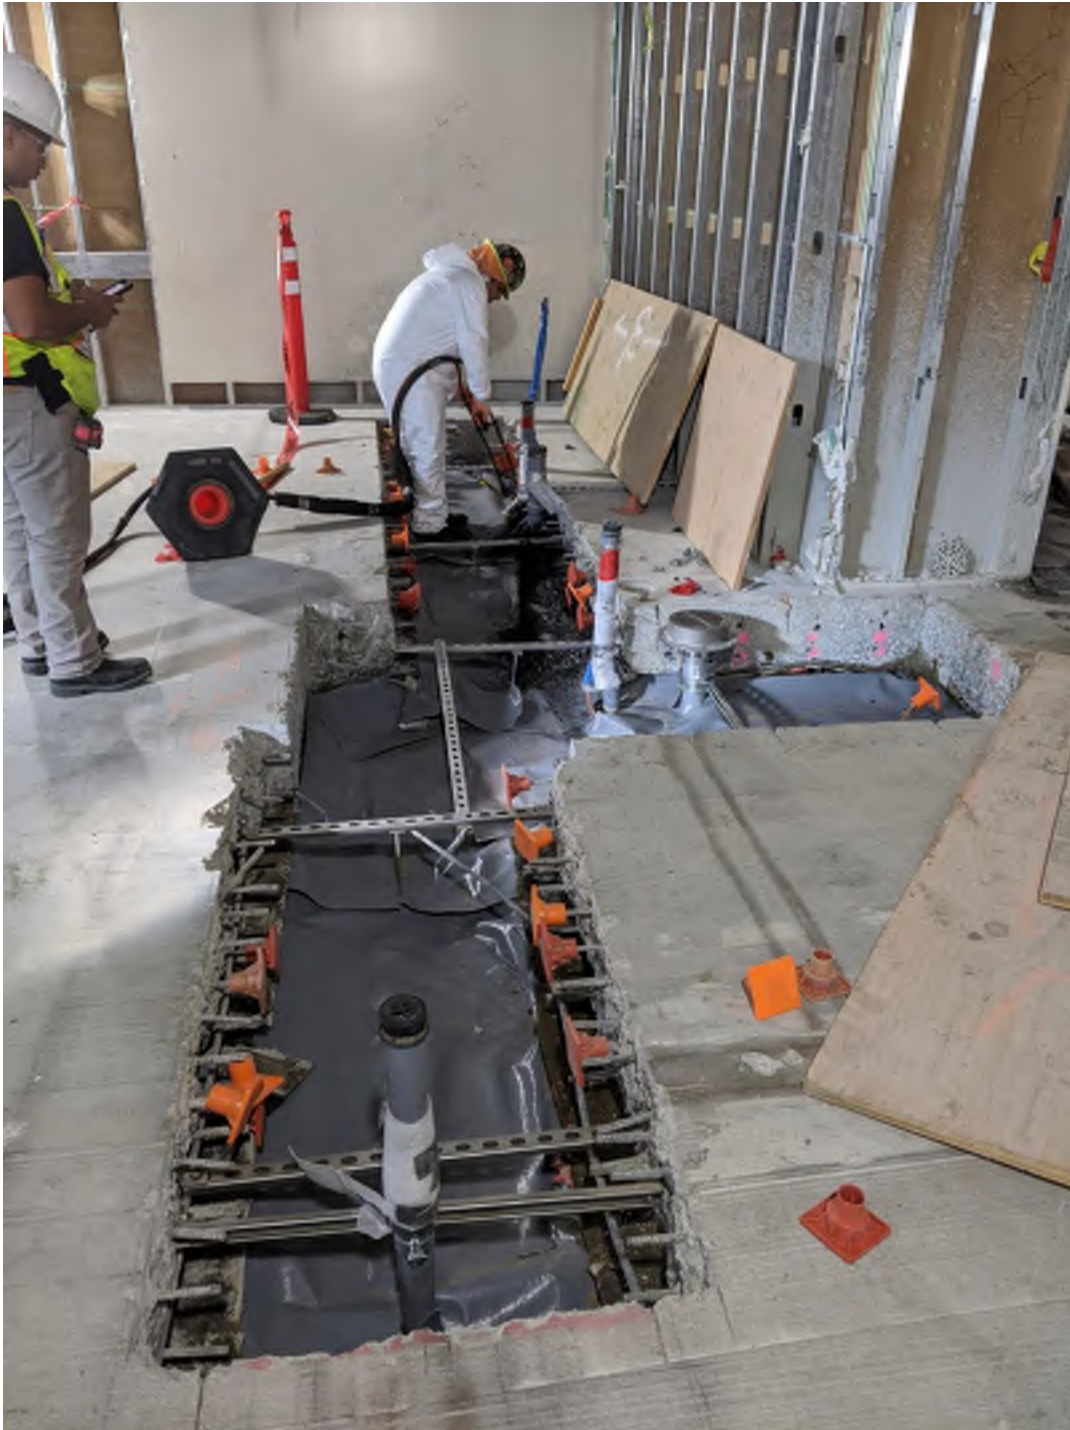
Photo 1: North Tower GMCSVMS repair work underway near loading dock door (facing west).

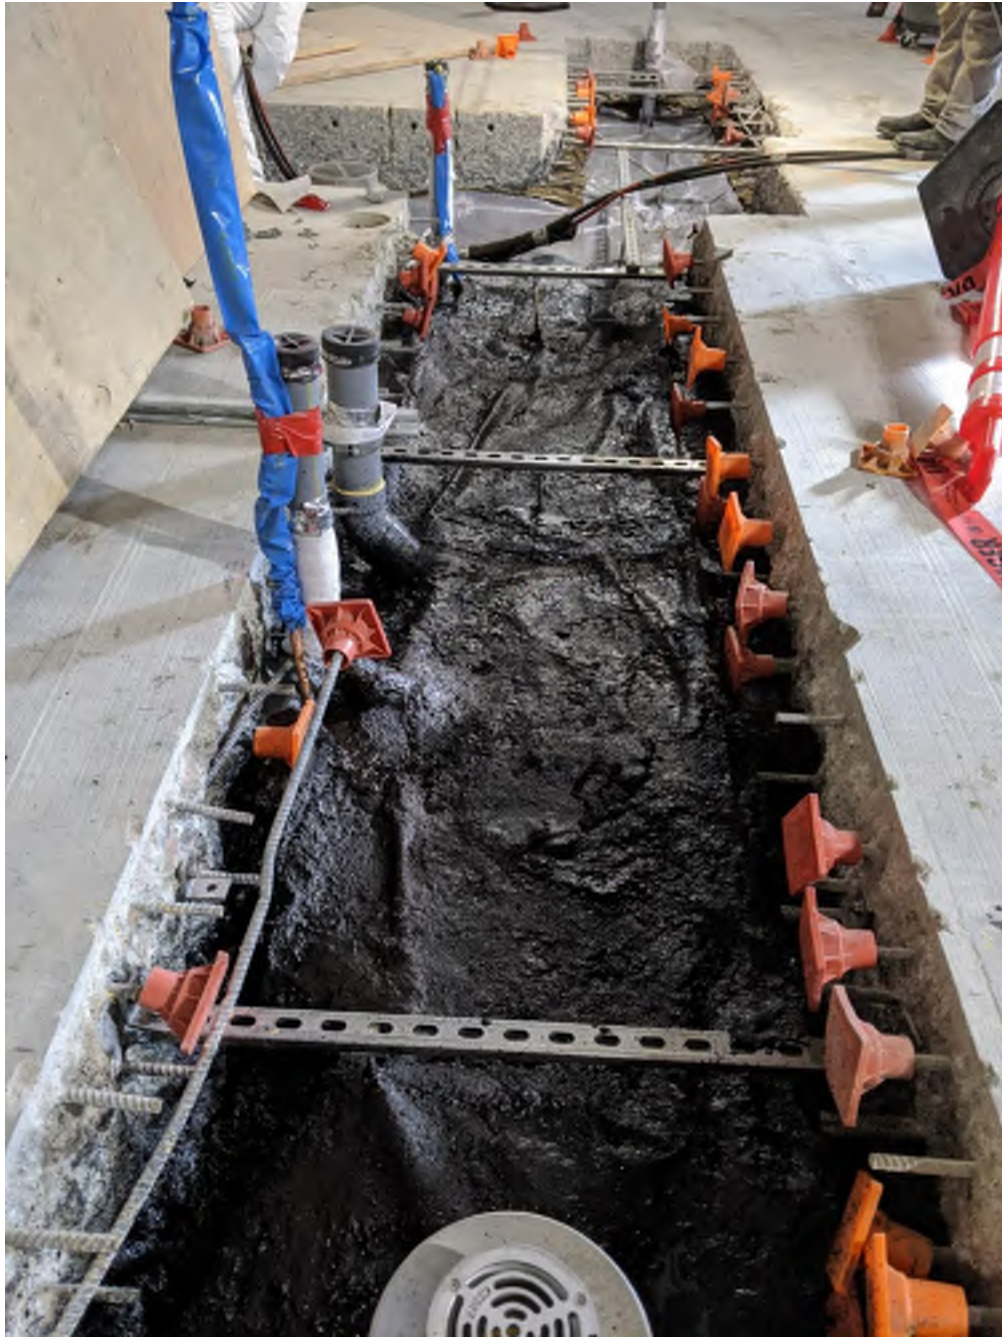
Photo 2: Progress of patching shown in Photo 1 (facing east).

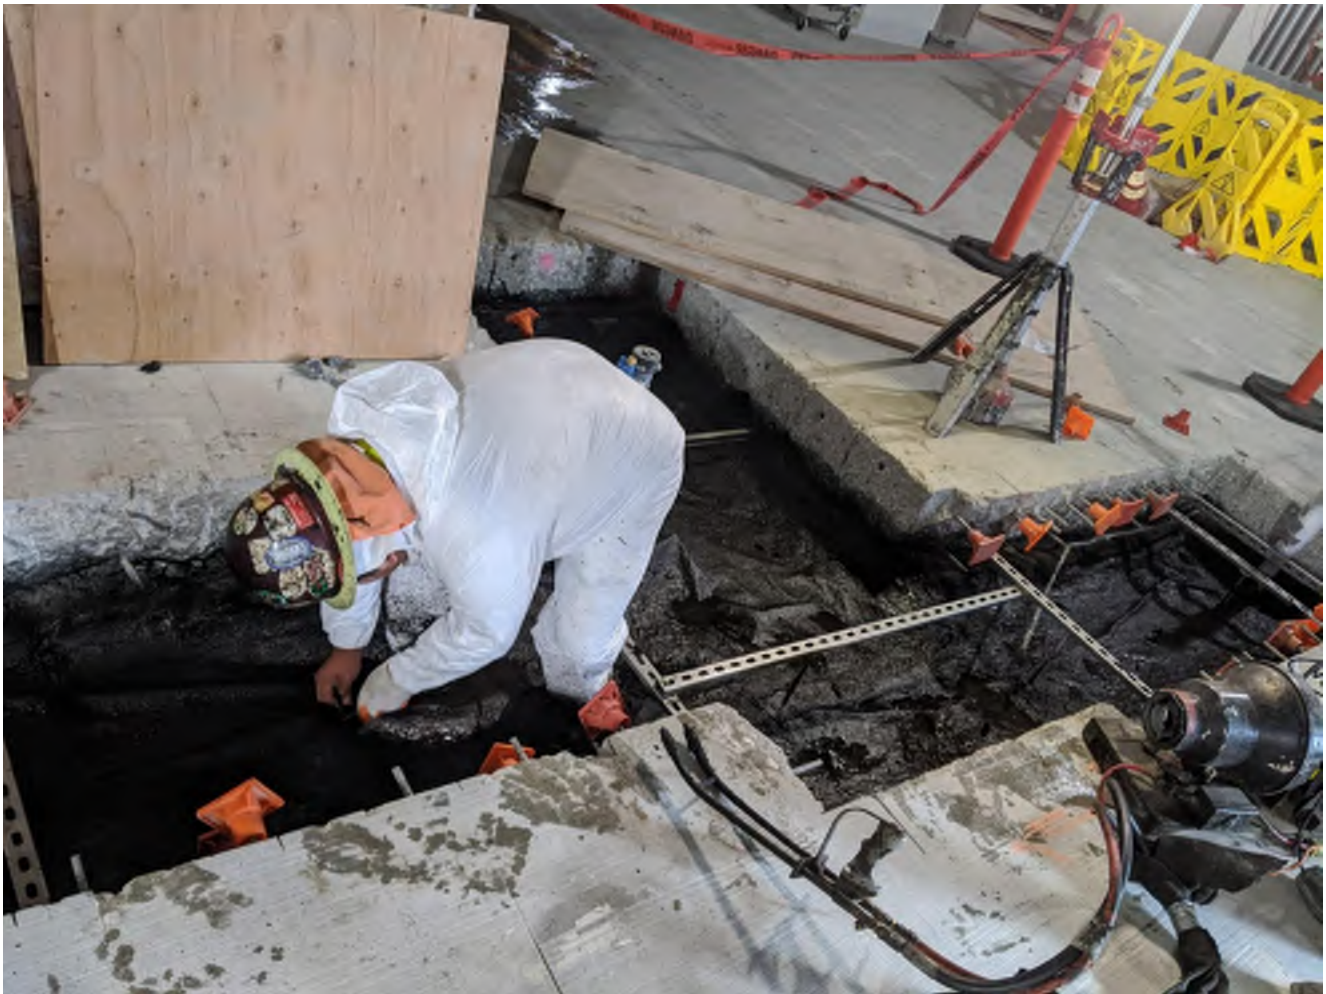
Photo 3: Progress of patching shown in Photo 1 (facing northeast).

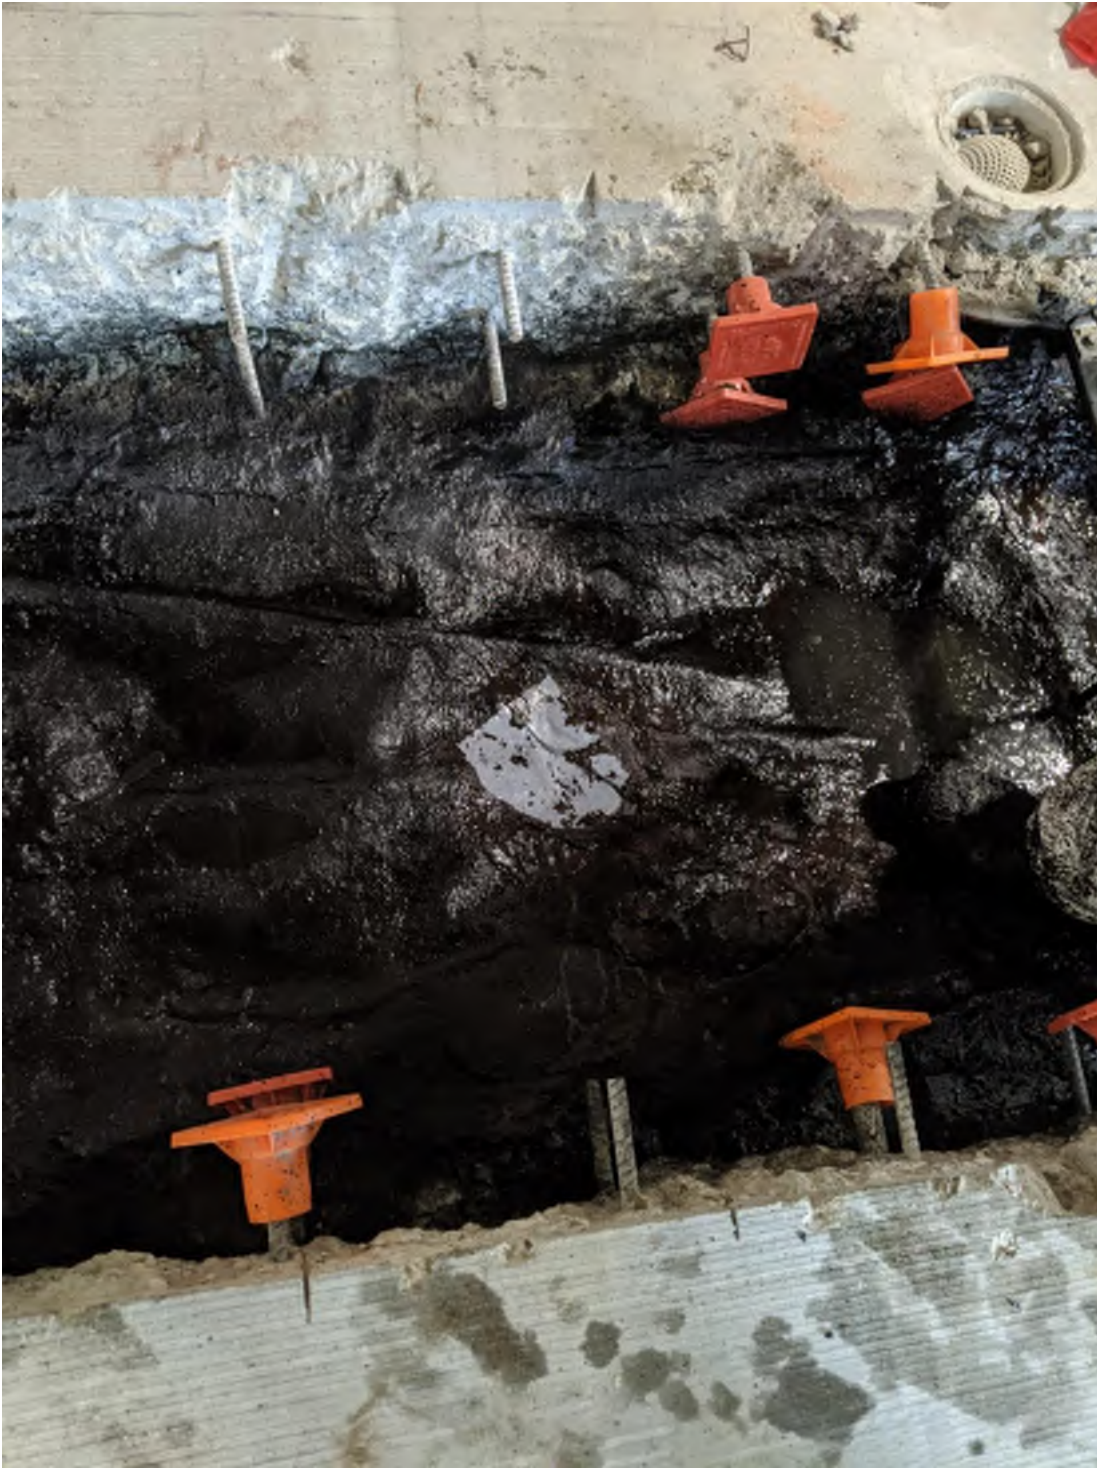
Photograph 43: Repair of area cut for smoke testing (facing north).

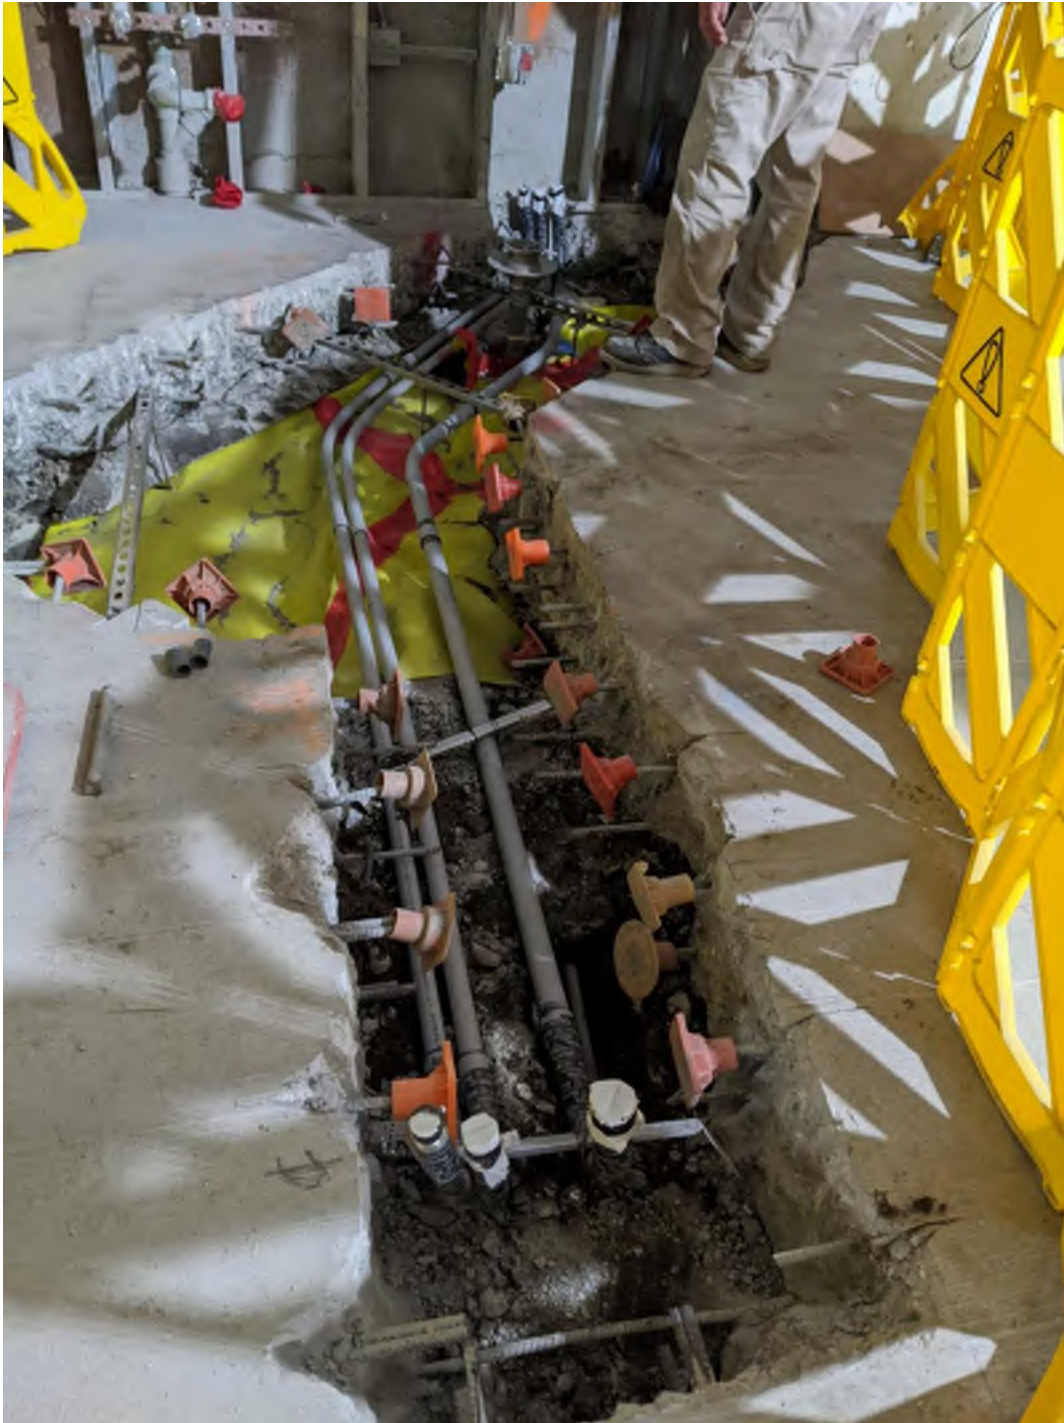
Photo 1: Preparation for EPRO application to north western most repair section (facing west).

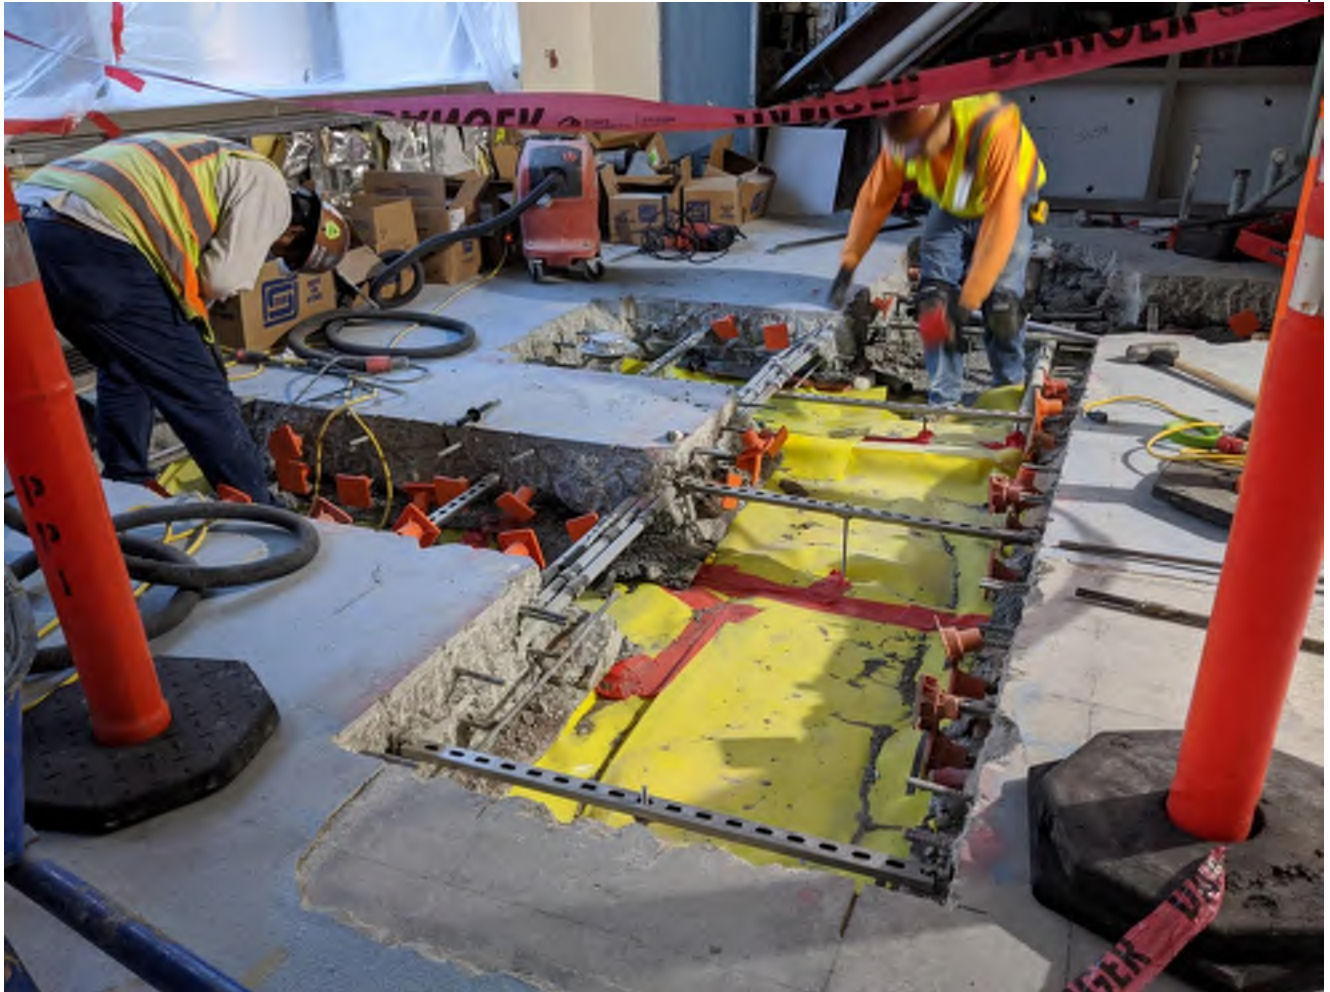
Photo 2: Preparation for EPRO application on north eastern-most repair section (facing east).

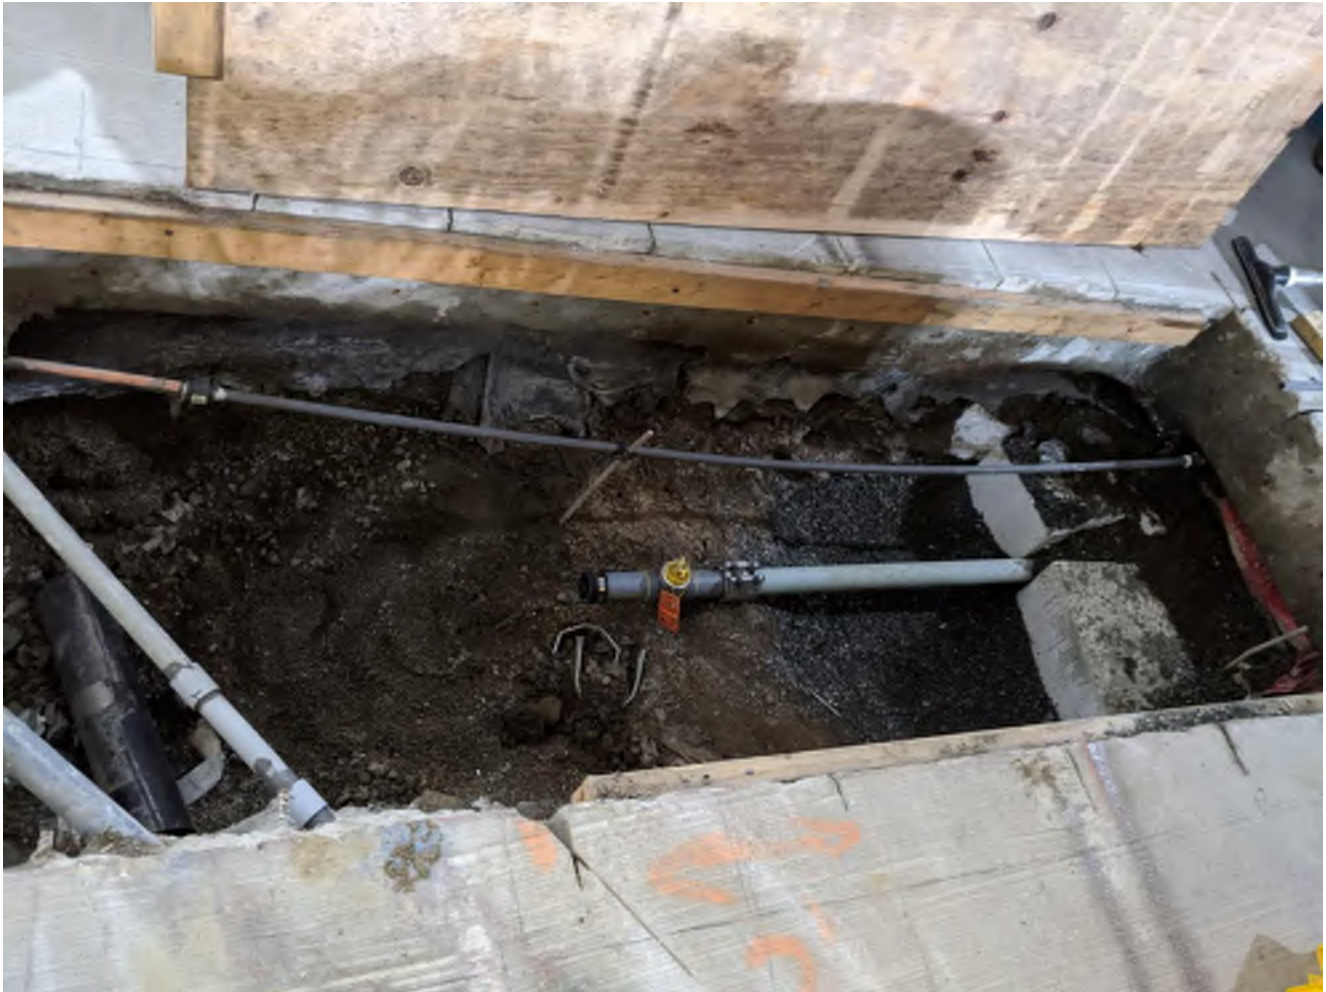
Photo 3: Progress of 1/2" solid gas monitoring pipe replacement (facing south).

1000 Daniel Wood returns to B48 to inspect ½" solid gas monitoring pipe repair. Pipe is repaired. EPRO vapor barrier membrane application to begin tomorrow (12-04-2019)

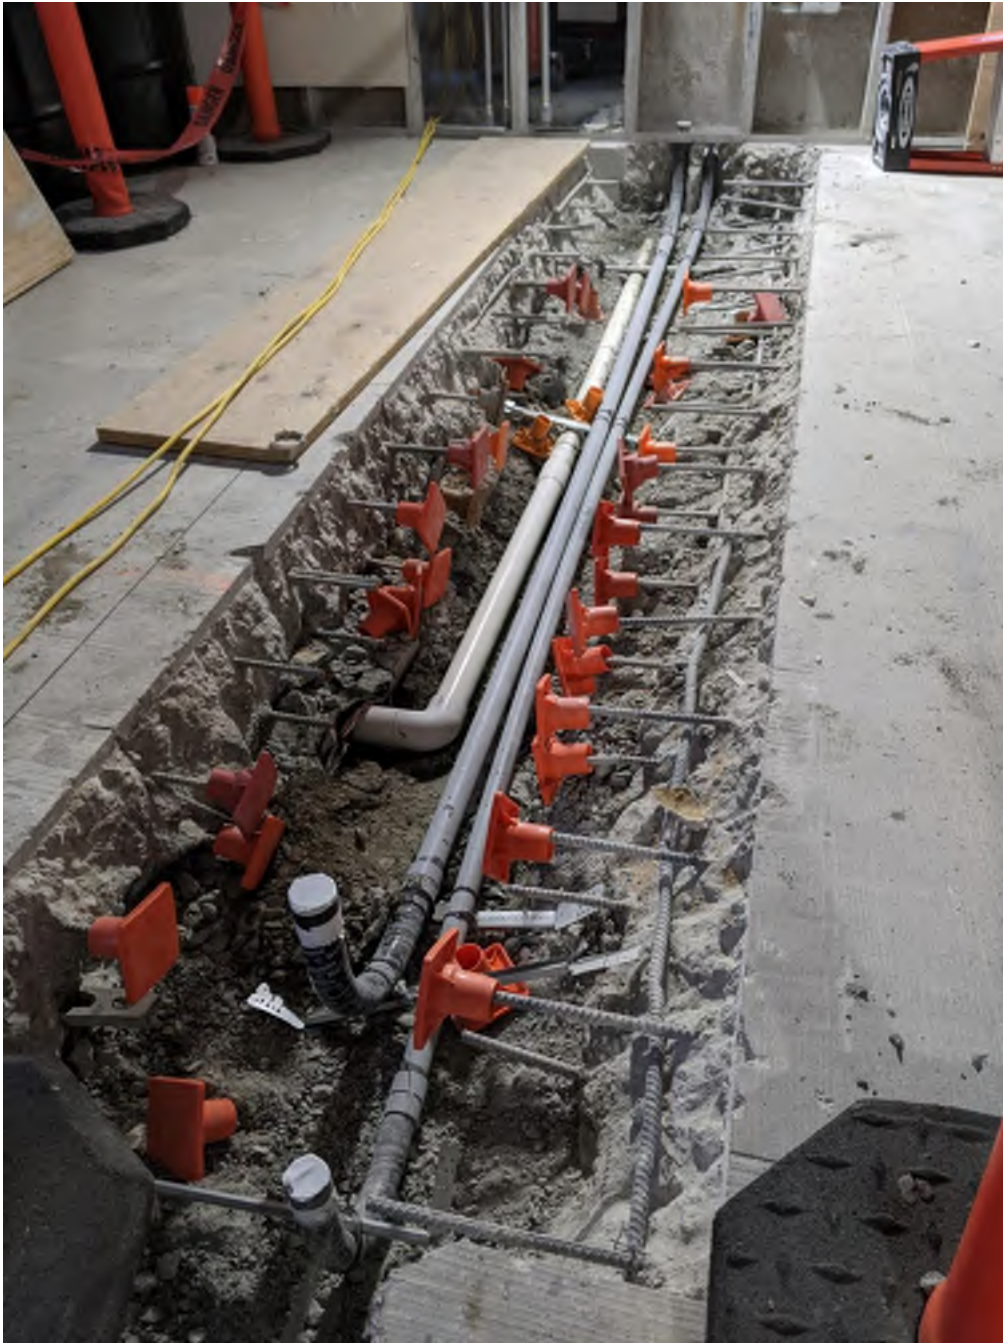
Photograph 4: Preparation for GMCS repair to center trenching area (facing north).

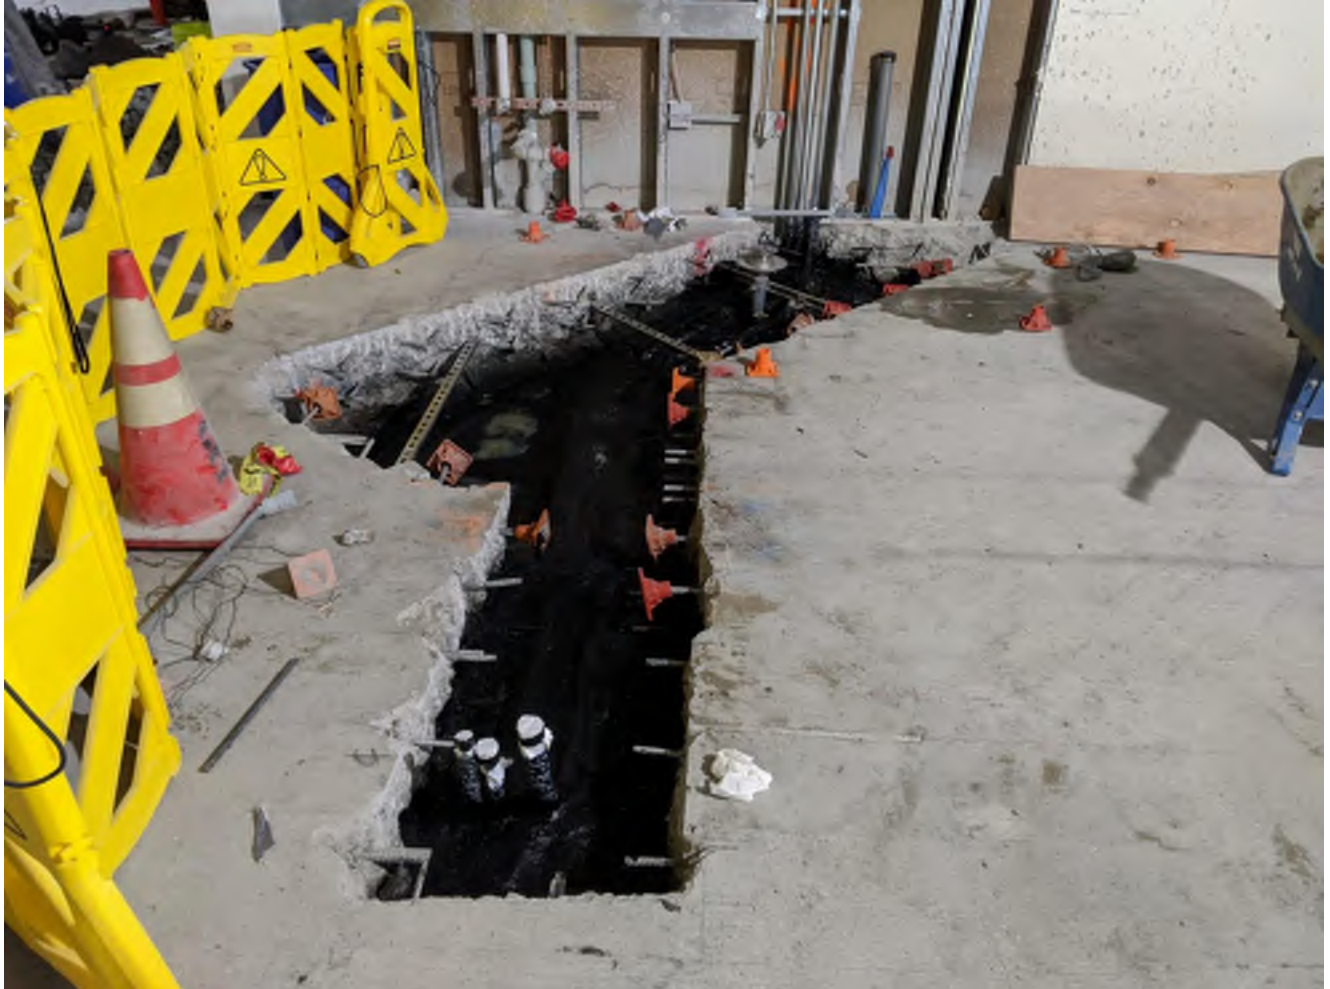
Photo 1: Post vapor barrier application to north western most repair section (facing west).

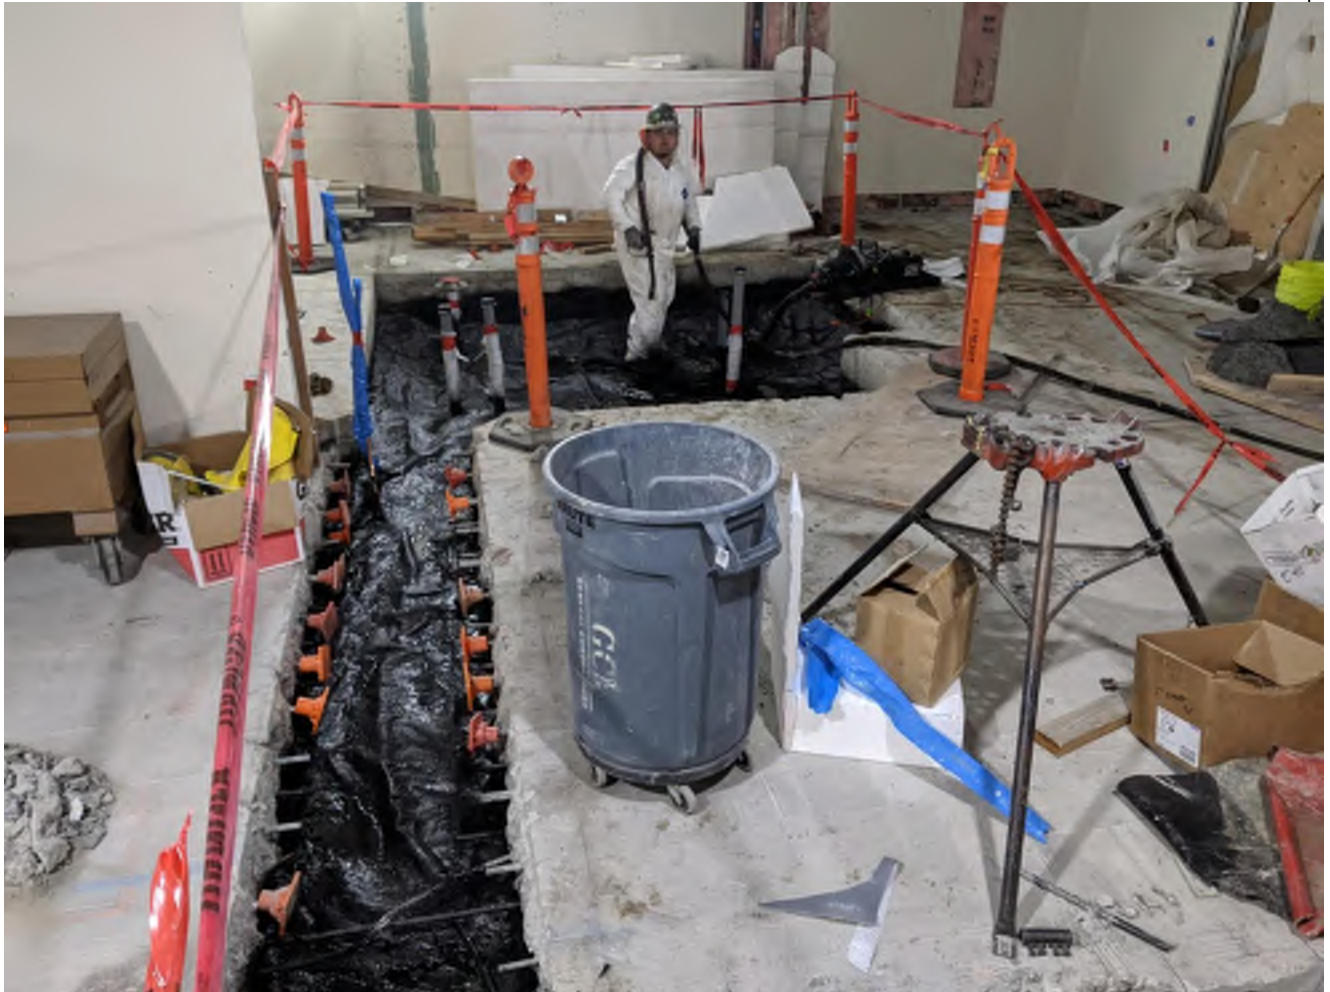
Photo 2: EPRO applied to eastern-most section of GMCS repair (facing east).

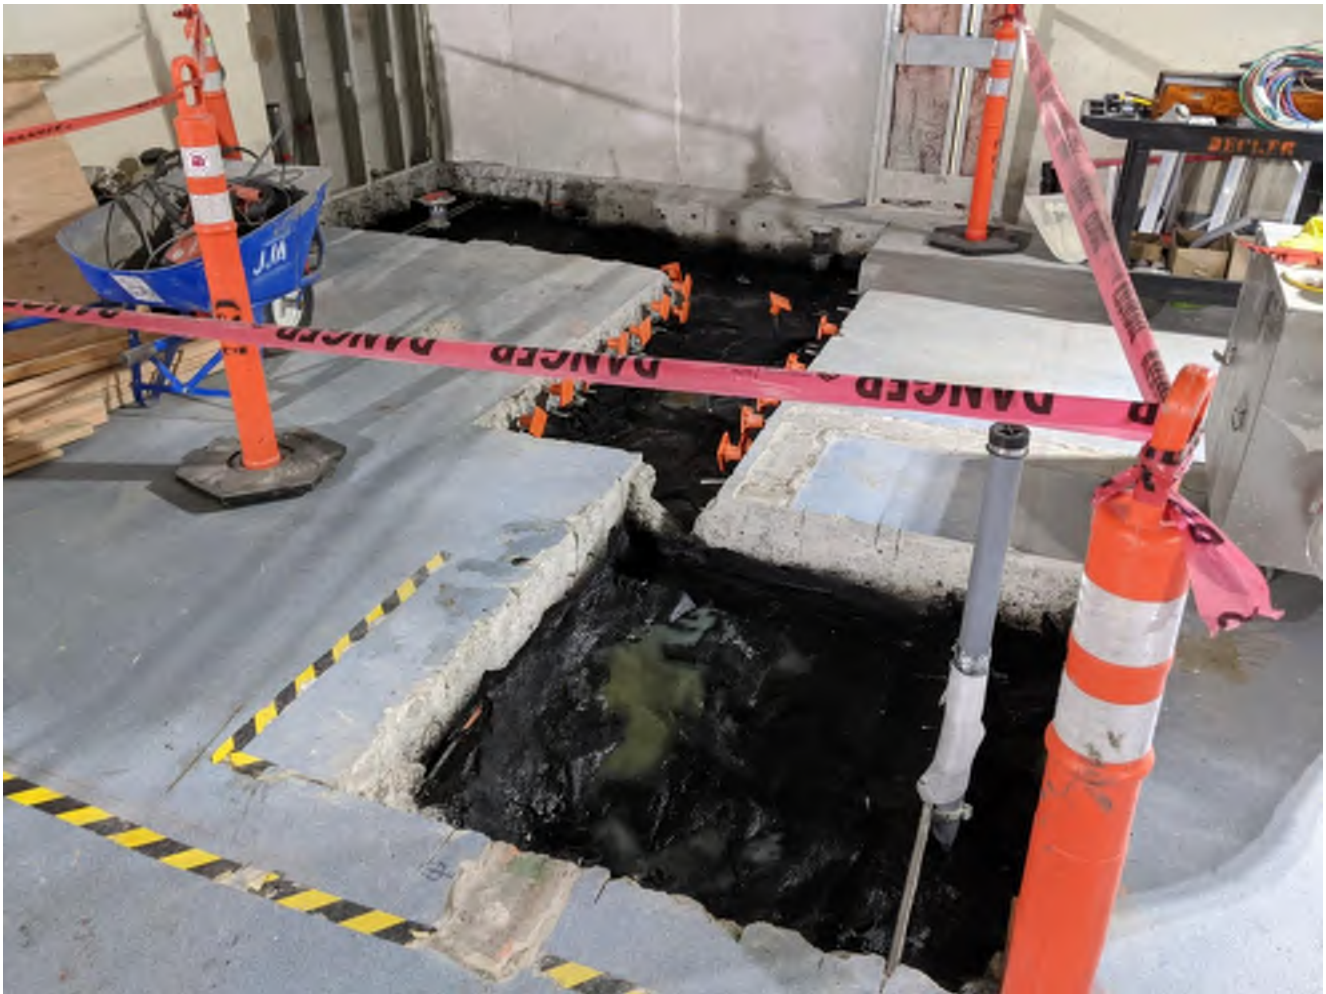
Photo 3: EPRO applied to center-most section of GMCS repair area (facing south).

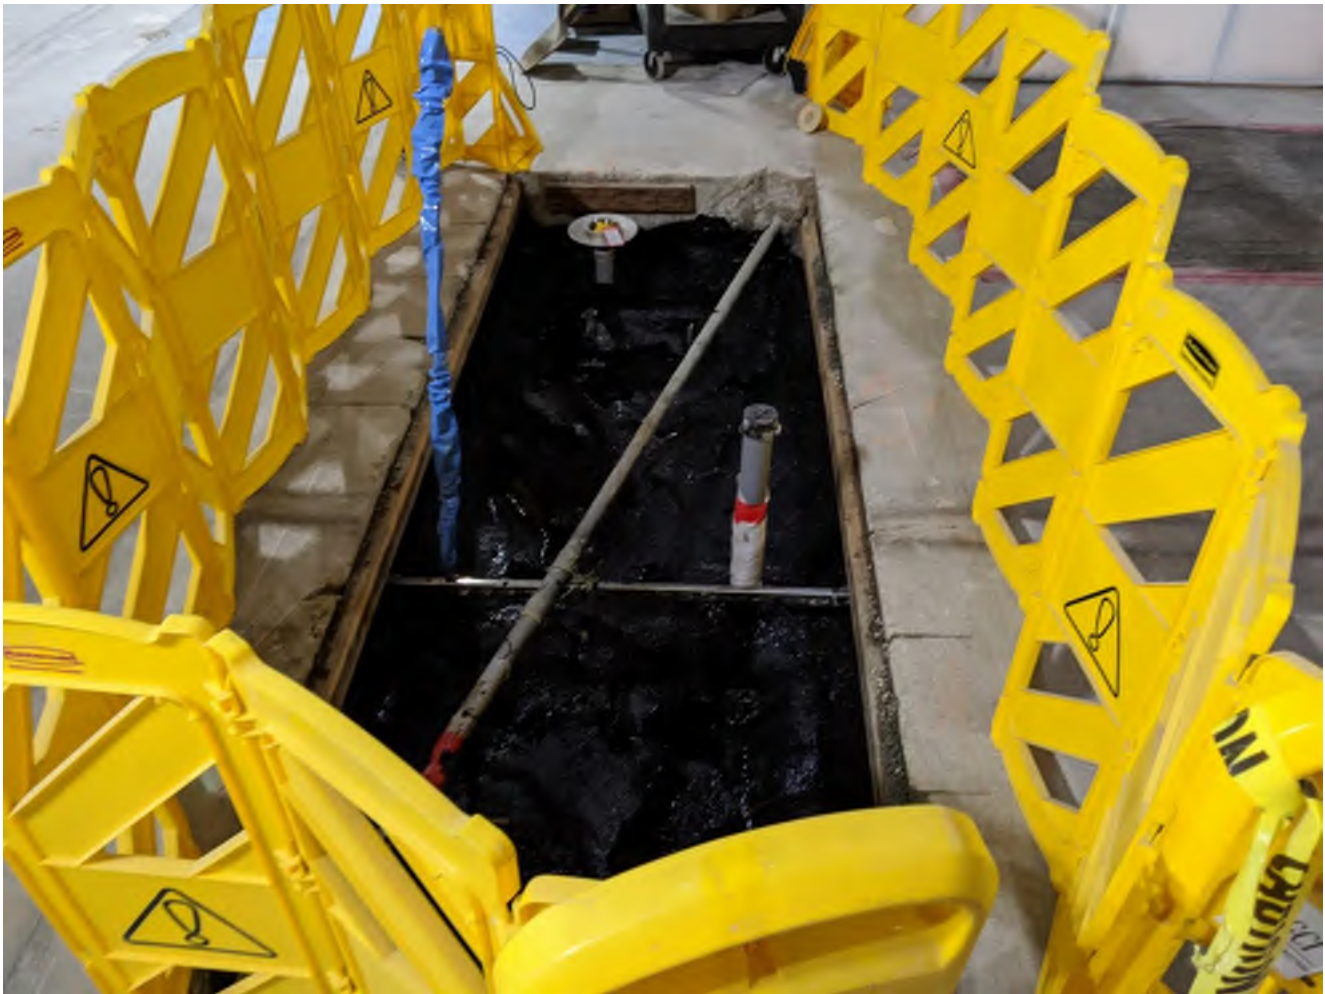
Photograph 4: EPRO applied to GMCS repair where ½" gas monitoring pipe was replaced (facing west).

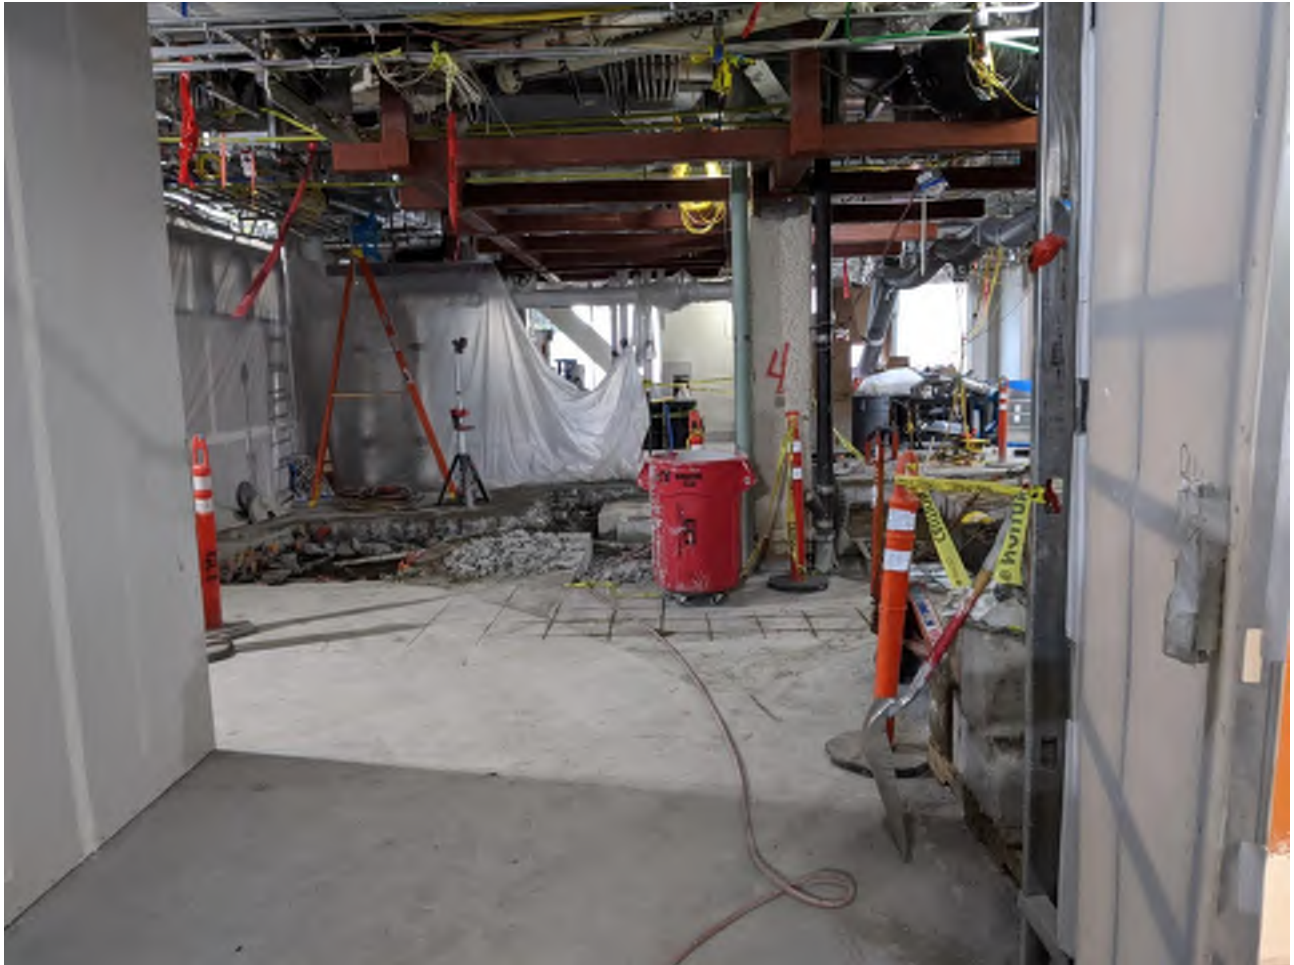
Photo 1: Wide view of Saw Cutting Phase 2 area from the loading dock entrance (facing north).

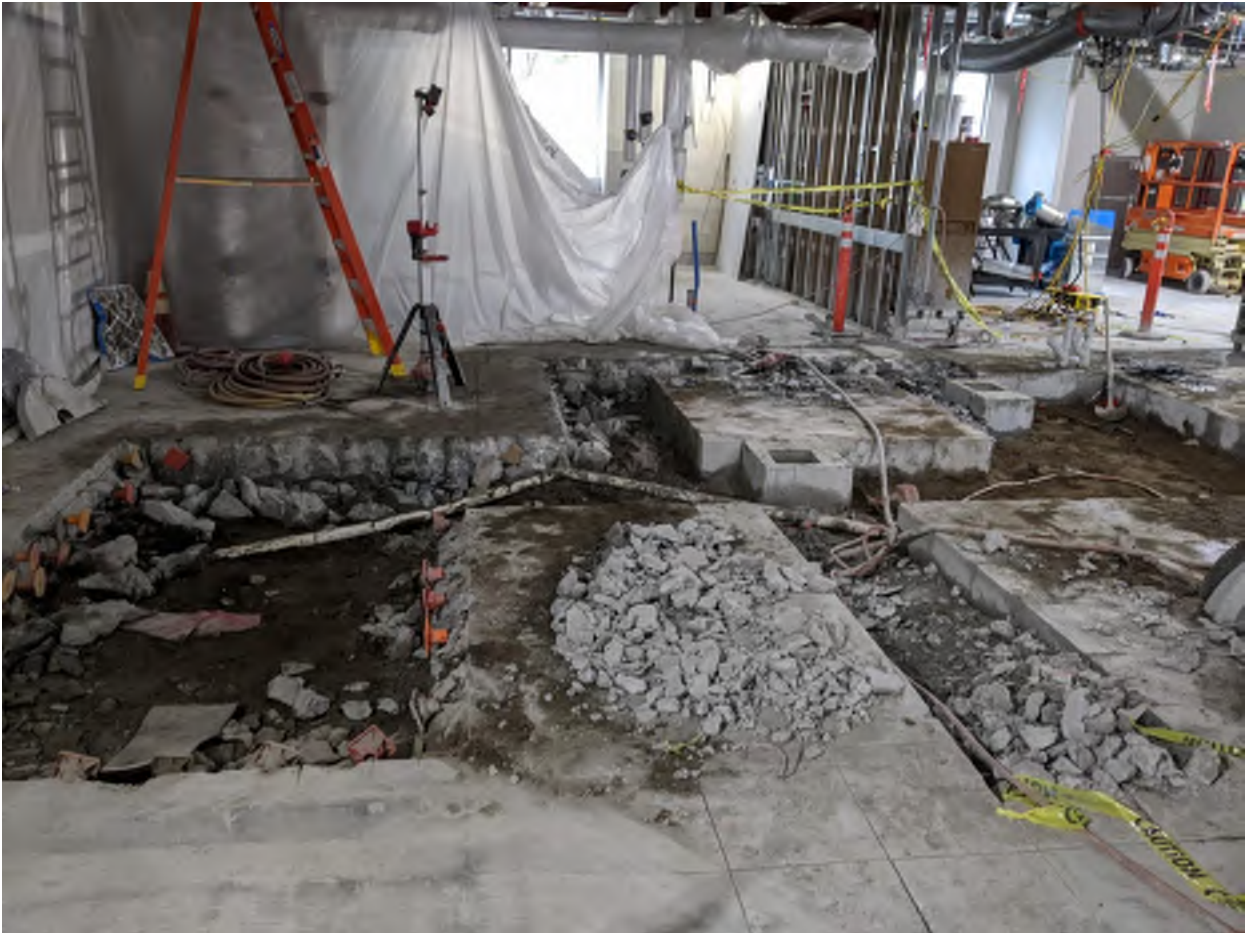
1030 Daniel Wood observes concrete cut during Phase 2 Saw Cutting. Location of cutting is ~~in middle of basement~~, adjacent to loading dock entrance. White 2" PVC gas extraction pipe cut during saw cutting to be repaired the following week prior to GMCS repair.

Photo 2: View of Saw Cutting Phase 2 and cut 2" PVC gas extraction pipe (facing north).

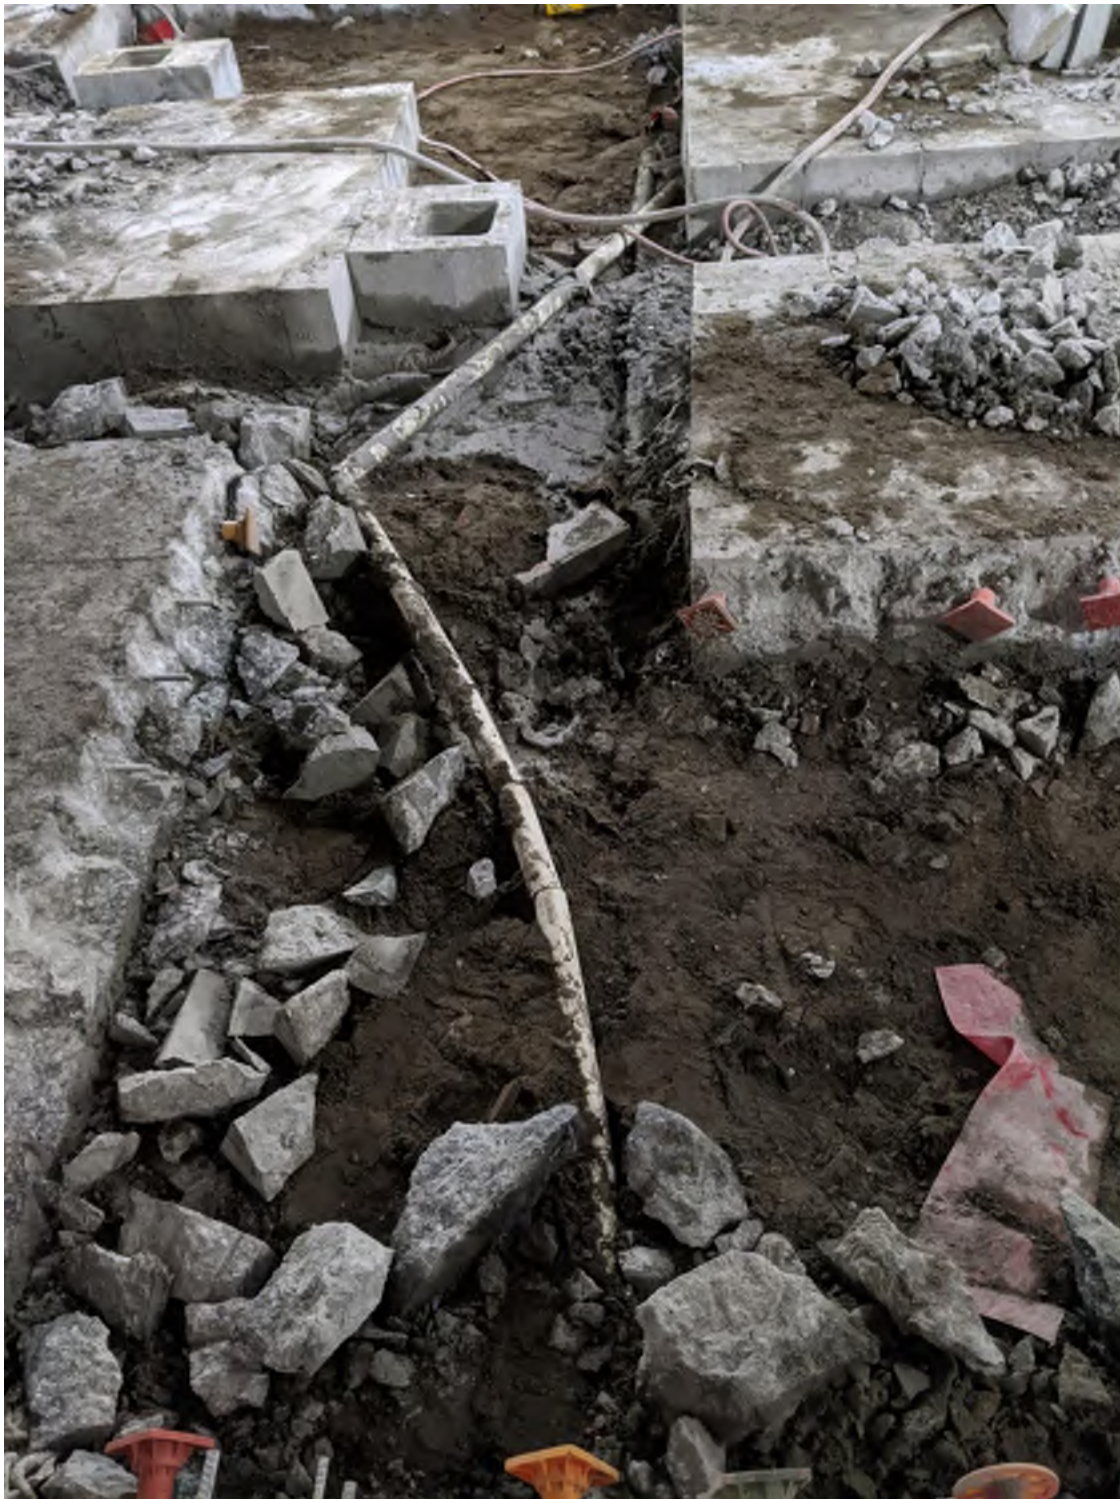
Photo 3: View of 2" PVC gas extraction pipe cut during Phase 2 Saw Cutting (facing west).

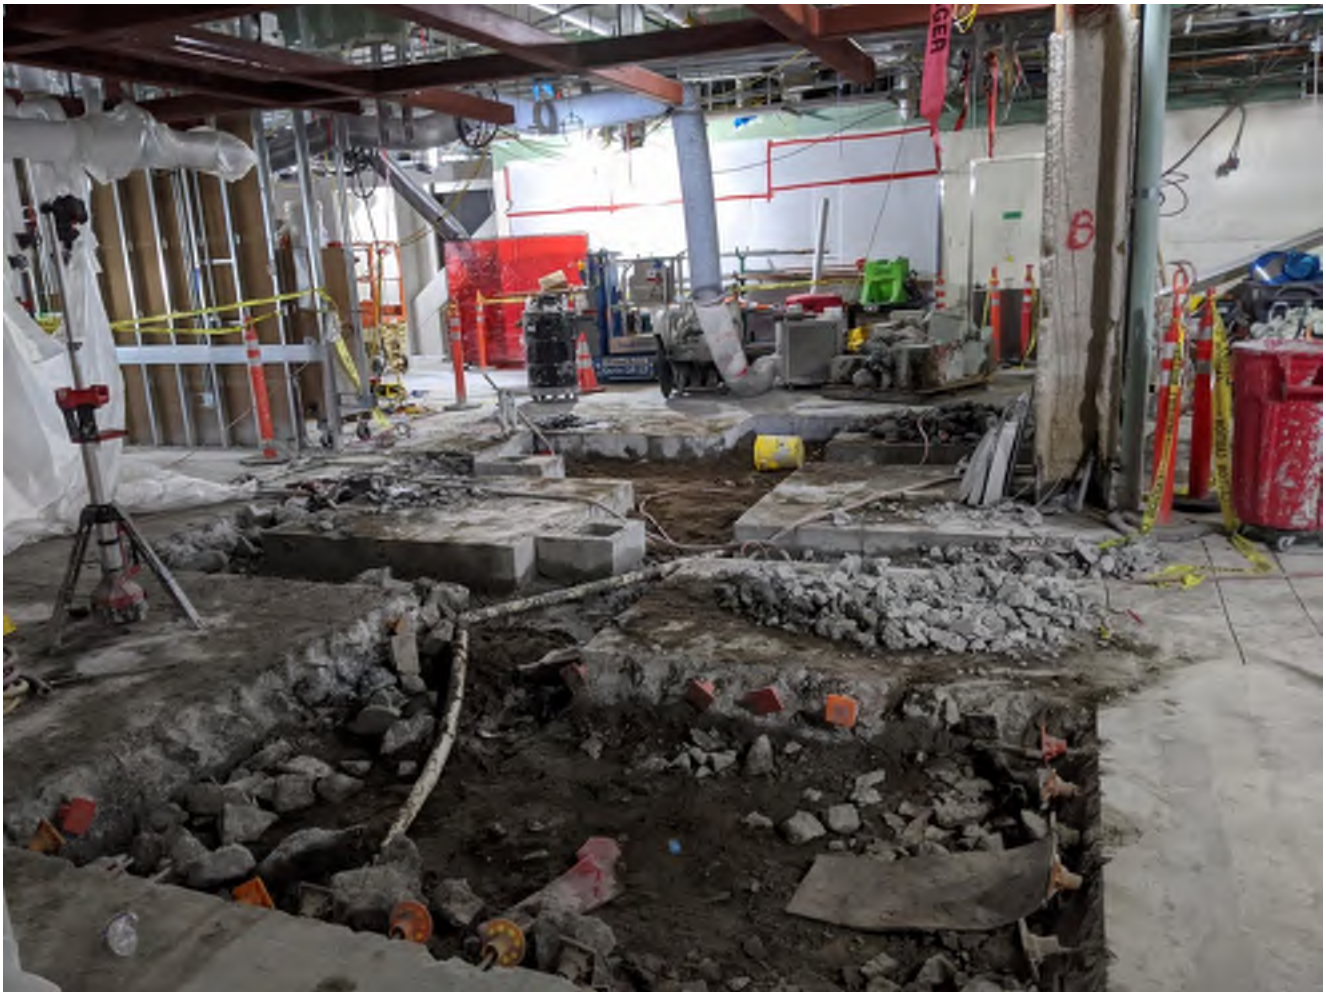
Photograph 4: View of Phase 2 Saw Cutting area and cut 2" PVC gas extraction pipe (facing west).
